Validation of F-16 wing attachment fitting bolts

NLR-TP-2008-097

Validation of F-16 Wing Attachment Fitting Bolts

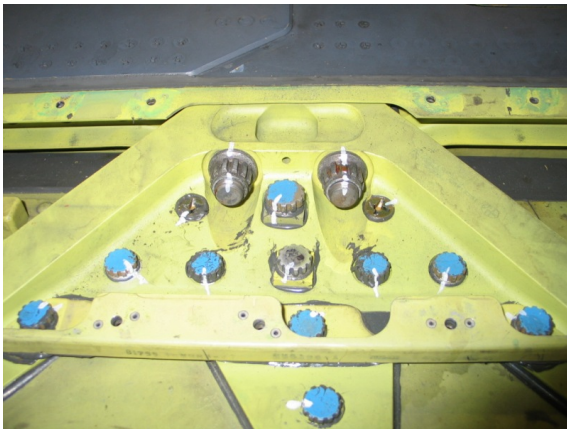
Example of surface rusting of WAF bolt ends and nuts

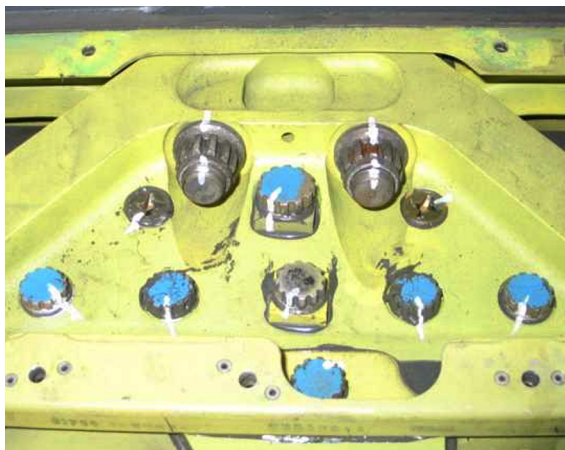
Fig. 1 *Example of a surface-rusted WAF bolt*

Scheduled inspections at two Royal Netherlands Air Force (RNLAf) bases revealed surface rusting of bolt ends and nuts in the Wing Attachment Fitting (WAF) steel bolt assemblies of 3 F-16 aircraft^[1], for example Fig. 1. Checks showed that all three aircraft had taken part in a wing modification programme, and that during this programme the WAF bolts, nuts and washers had been immersed for up to 3 days in a bath of paint stripper, which is a non-approved cleaning liquid. The paint stripper removed significant amounts of the cadmium plating originally applied to the bolts, nuts and washers.

The CMT cleared the aircraft for further operation, whereby all the remaining WAF bolt assemblies were cleaned with an approved cleaner and protected with primer. These assemblies were subsequently replaced *at the latest* during the next scheduled inspection.
